Situation Photo Log

Thursday, August 16, 2012

Kalamazoo River / Enbridge Spill

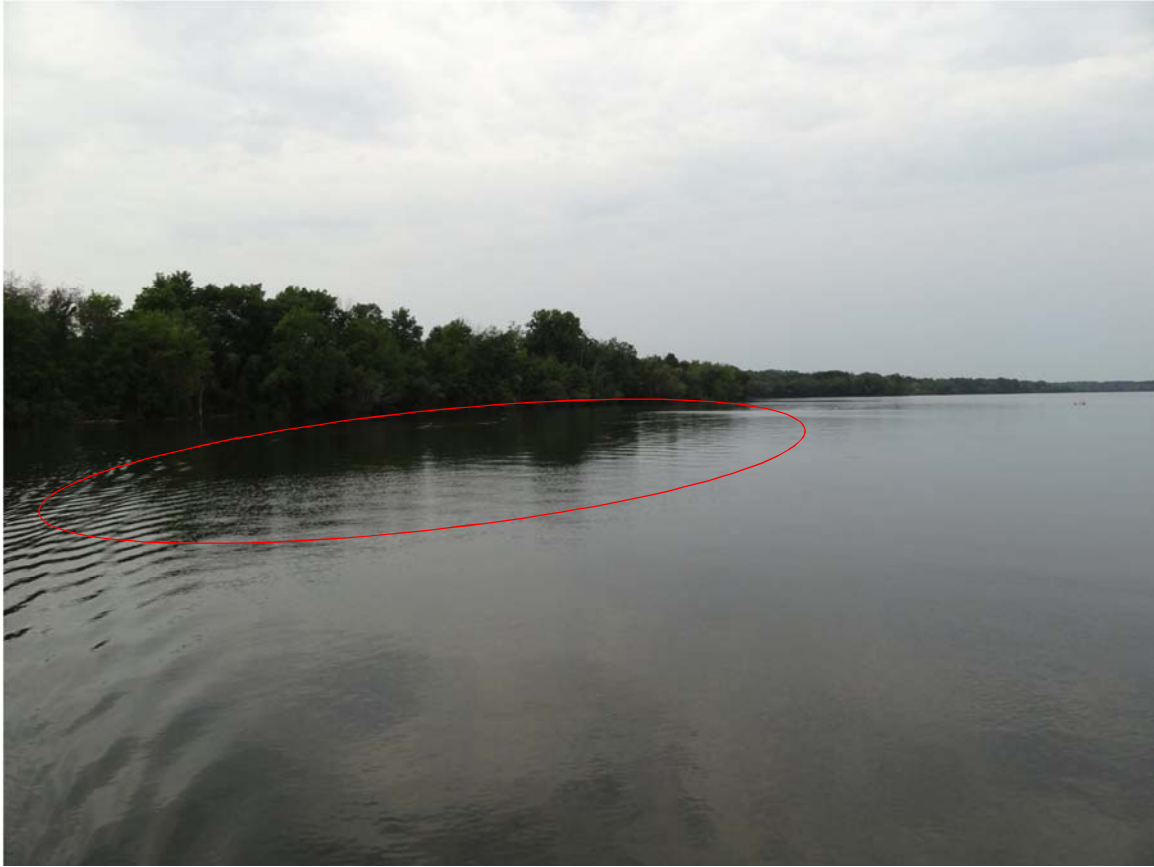
1. Morrow Lake southeastern cove area where sheen was observed.

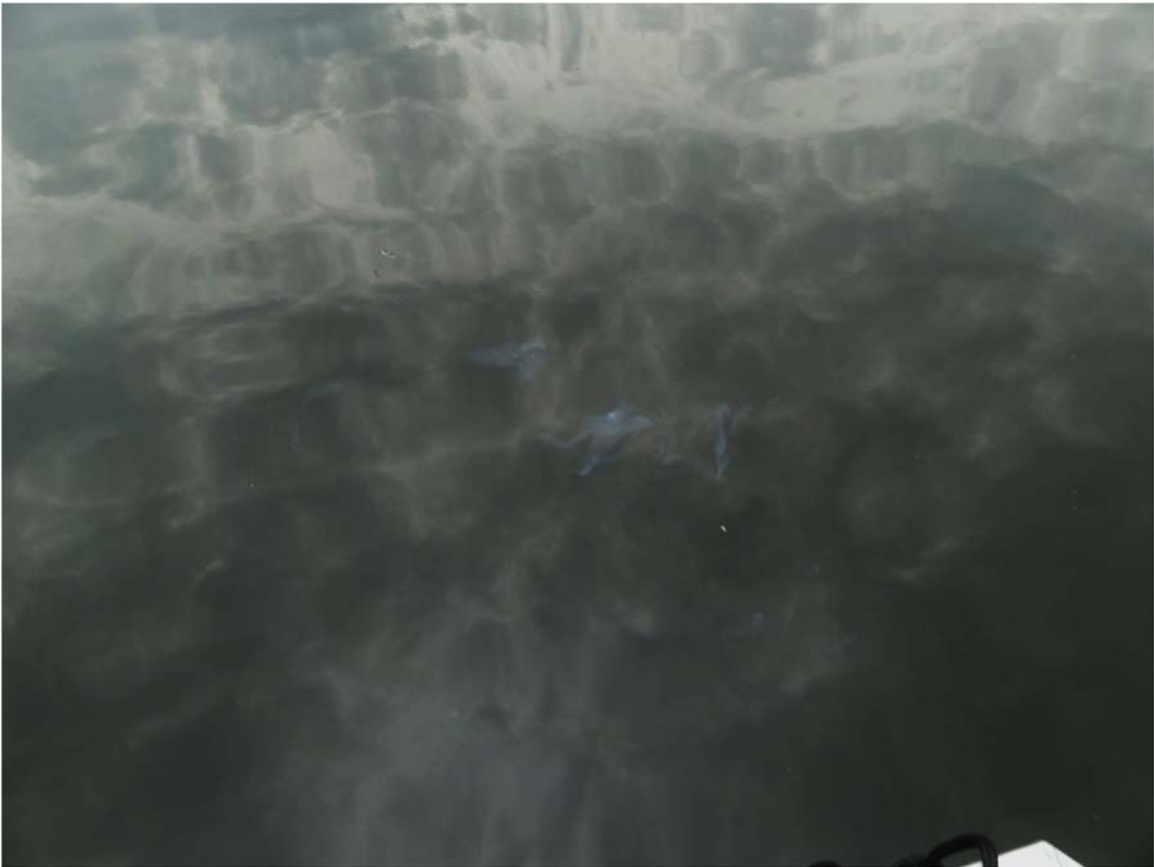
2. Morrow Lake southeastern cove sheen was observed.

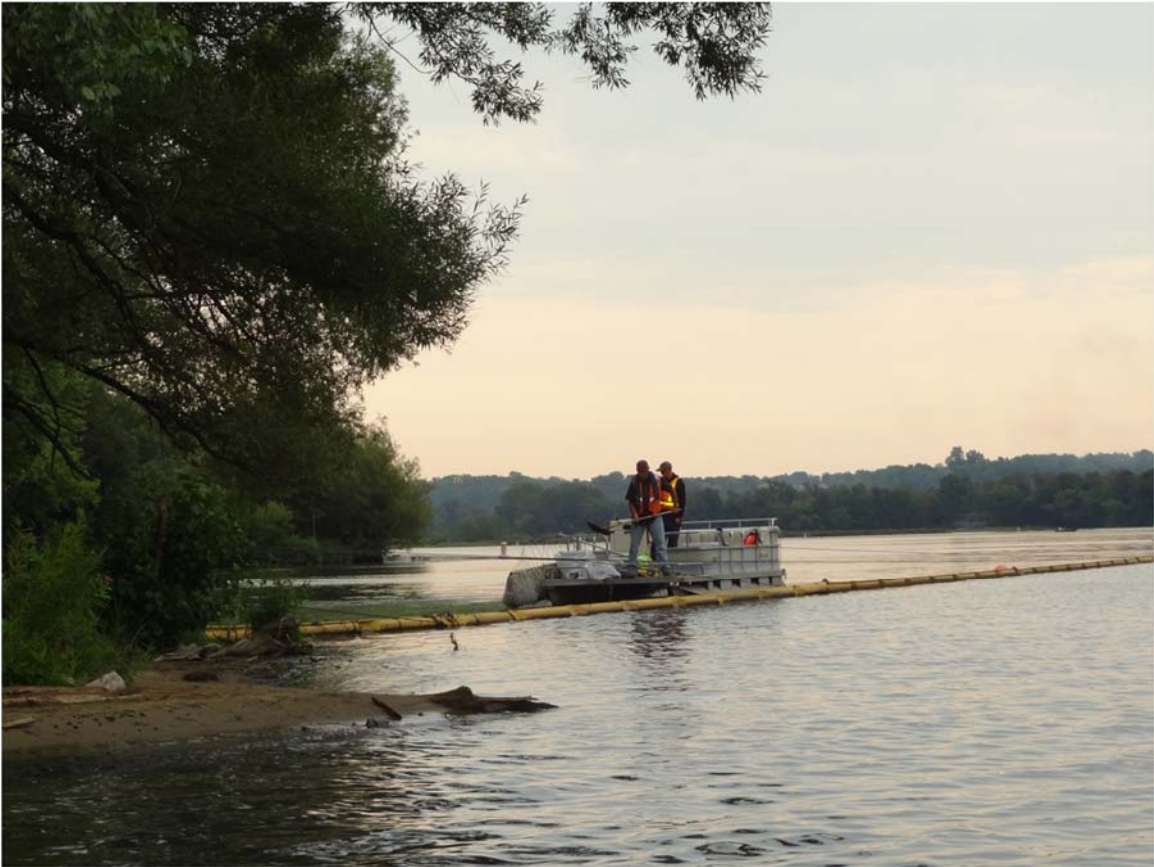
3. Morrow Lake Delta observed crews removing debris from Boom E.

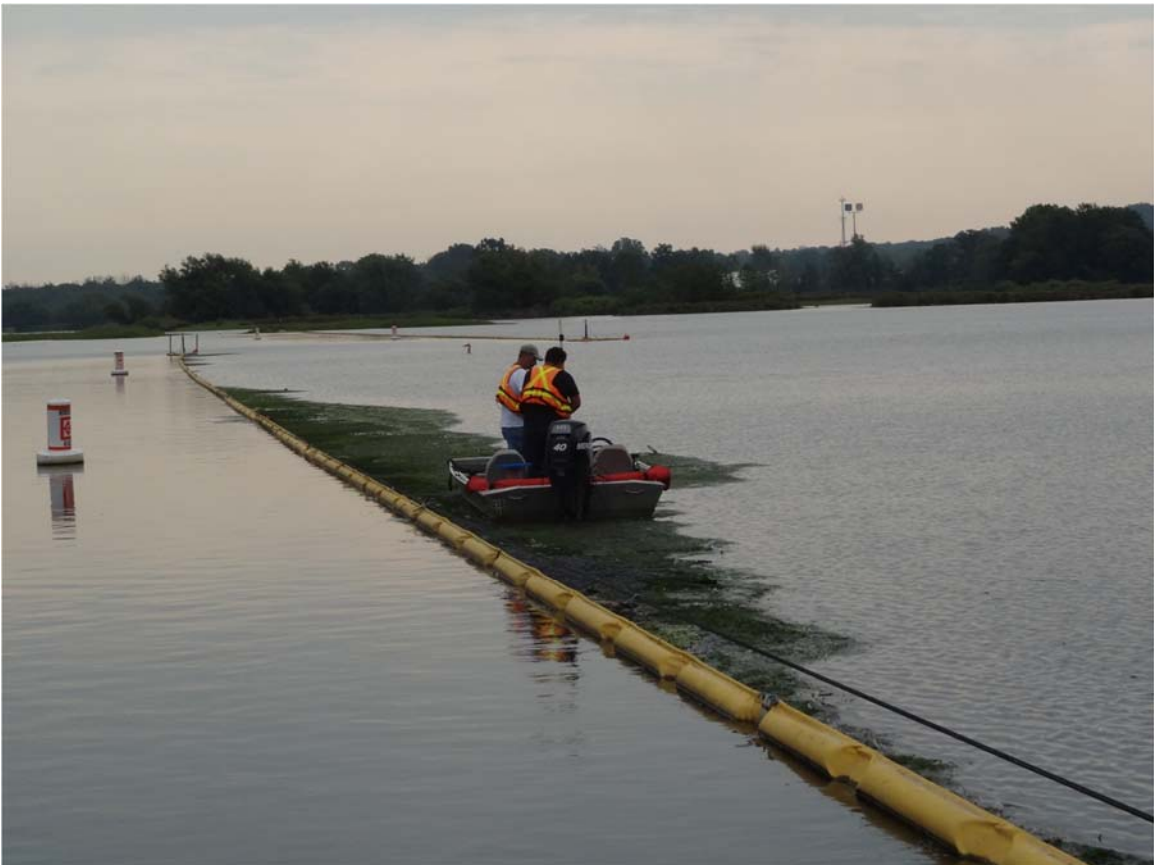
4. Morrow Lake Delta observed crews removing debris from Boom C.

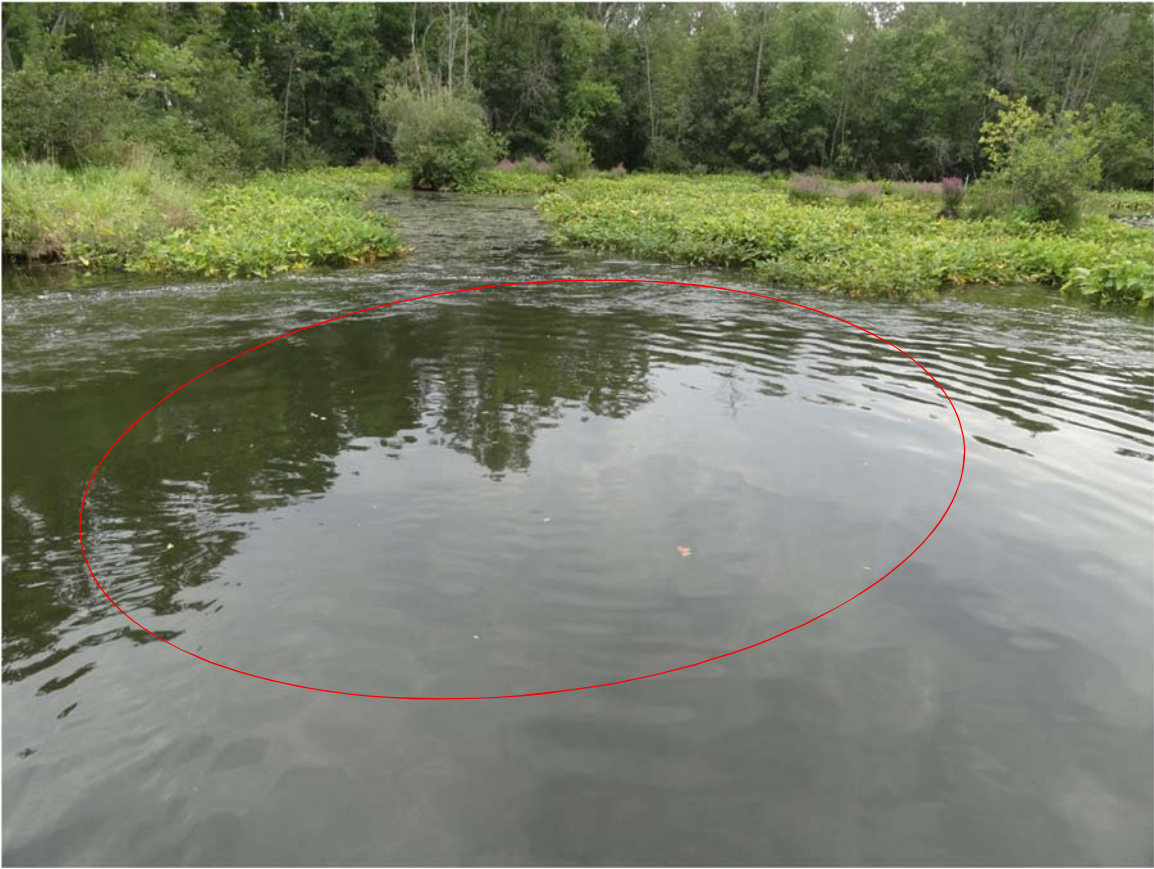
5. MP36.5 RDB area where sheen was observed.

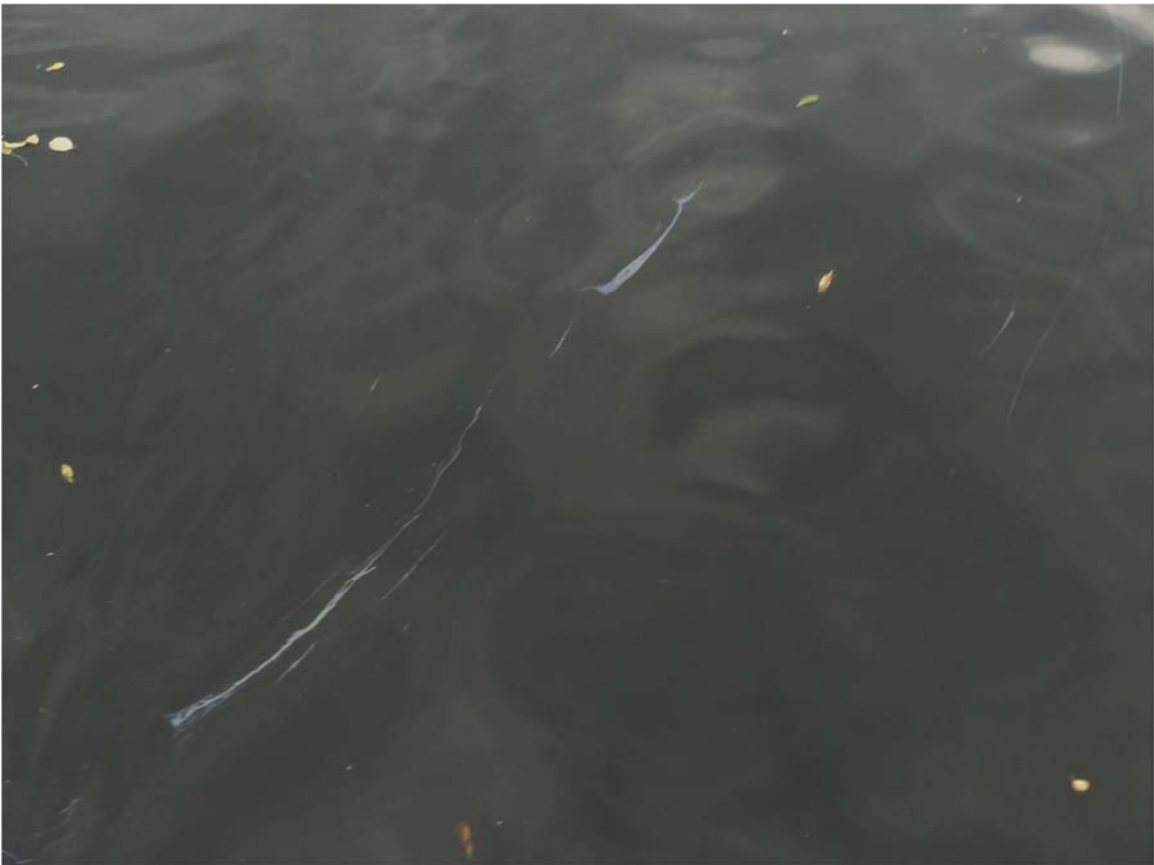
6. MP36.5 RDB sheen was observed.

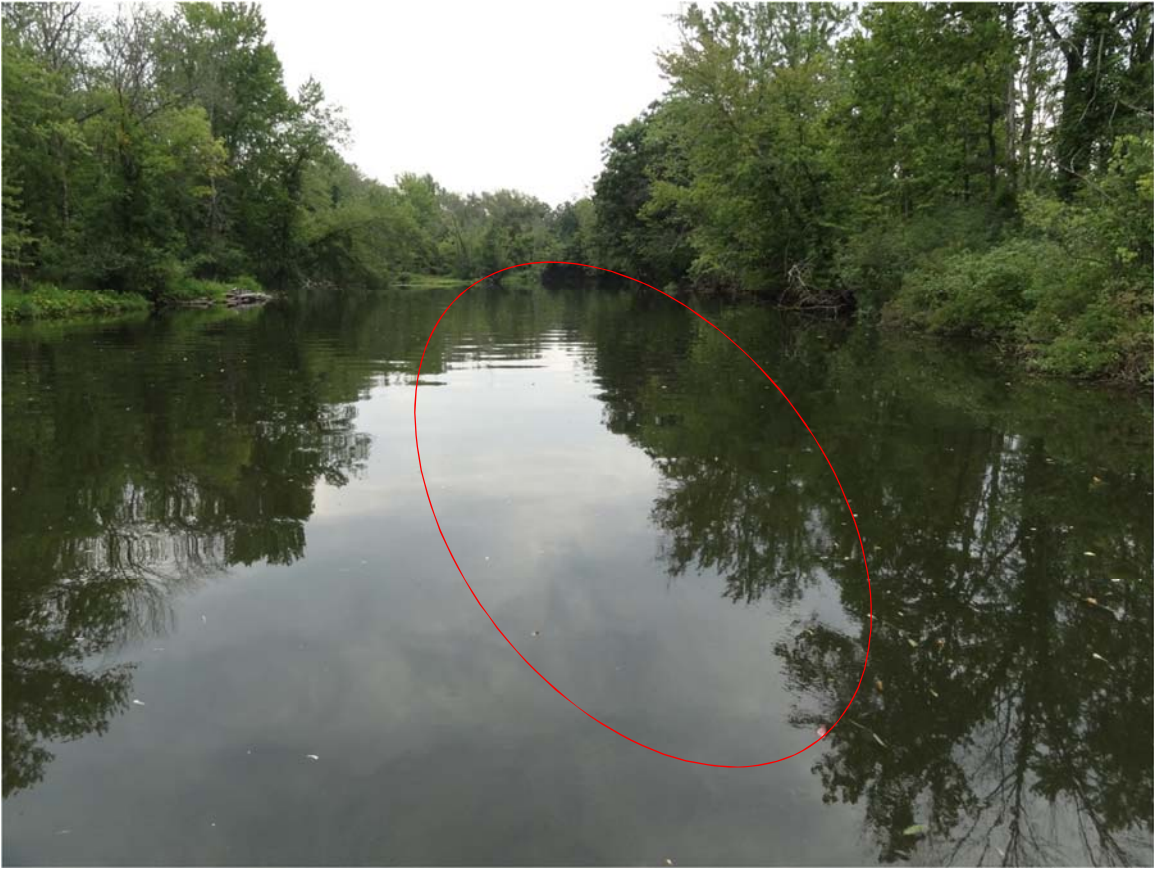
7. MP36.25 LDB area where sheen was observed.

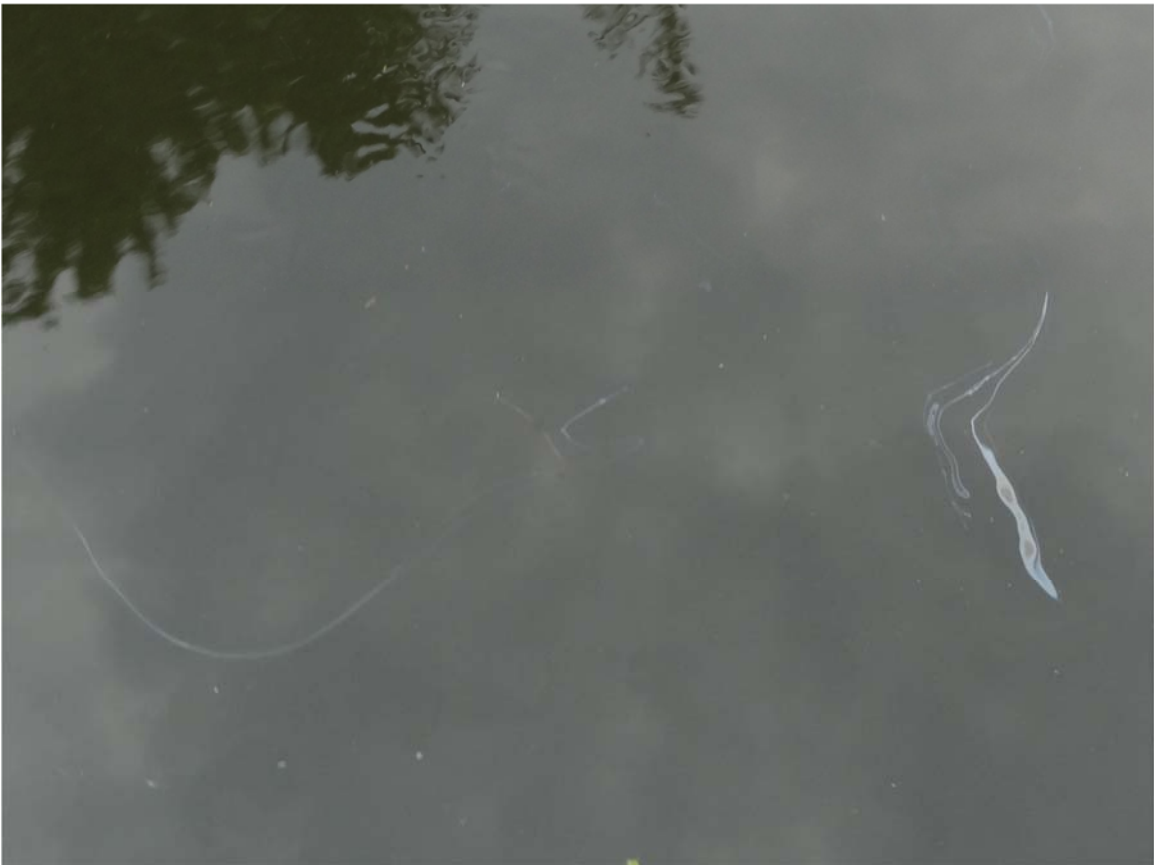
8. MP36.25 LDB sheen was observed.

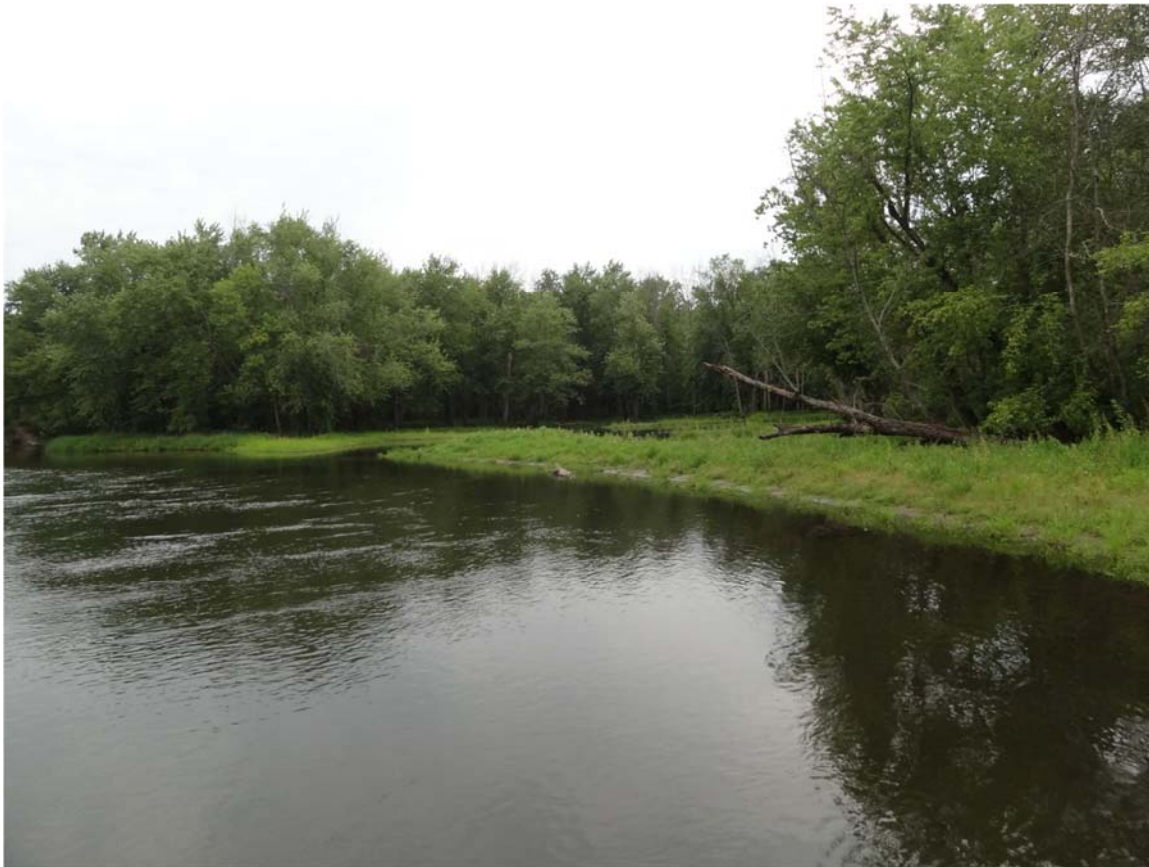
9. MP30.8 LDB no sheen observed.

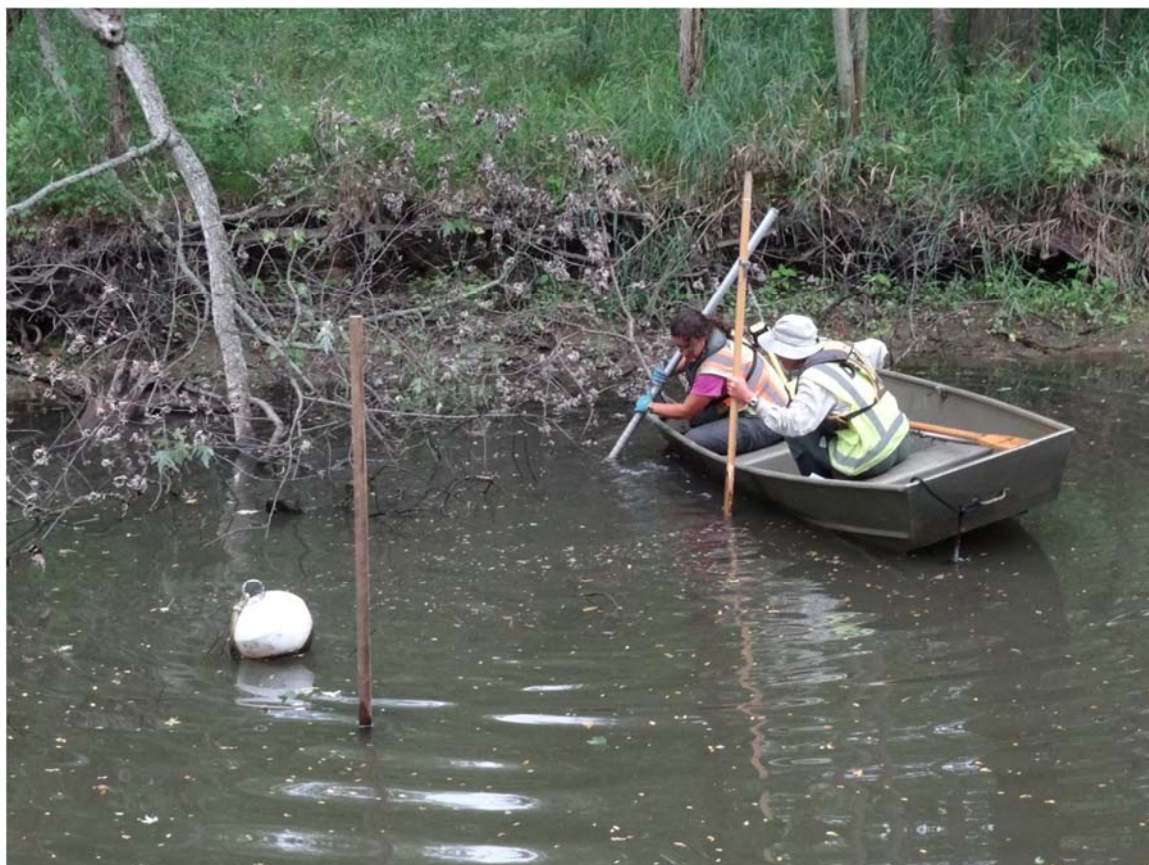
10. MP28.25 Oxbow observed crew performing monthly sediment trap monitoring.

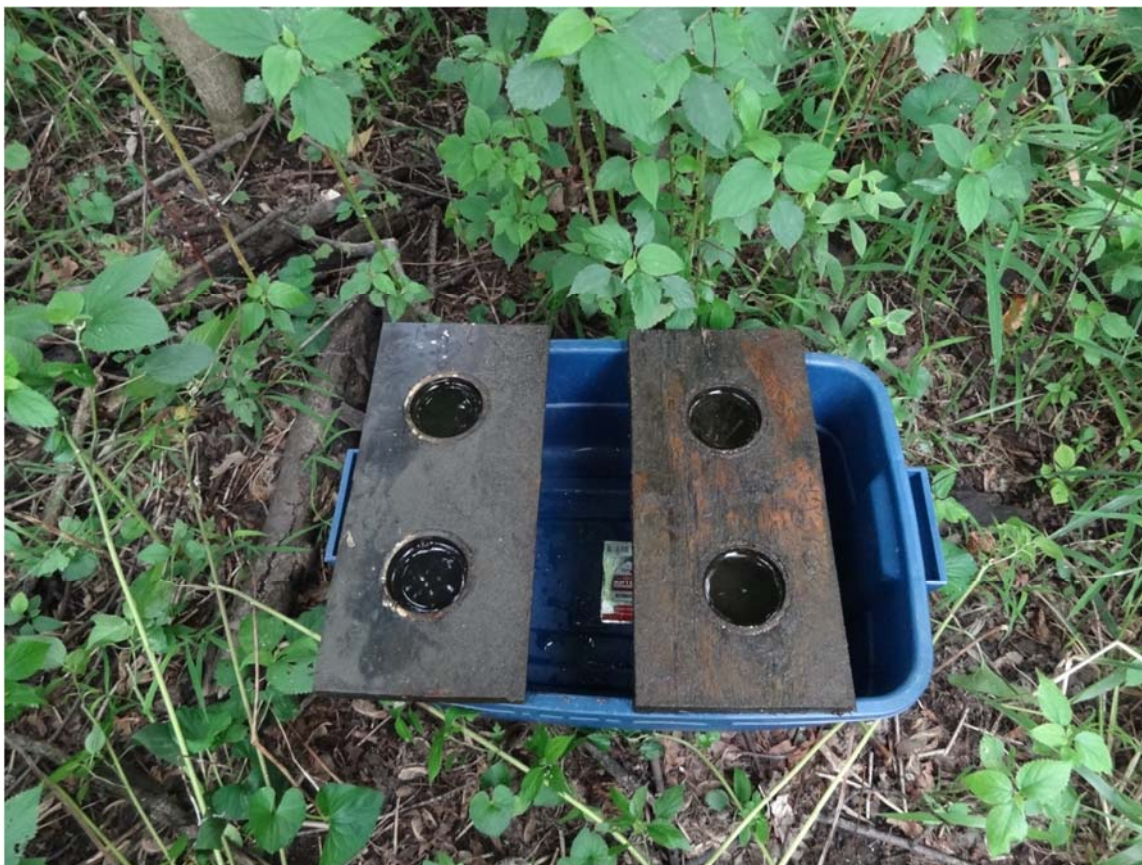
11. MP28.25 CSD observed being sampled.

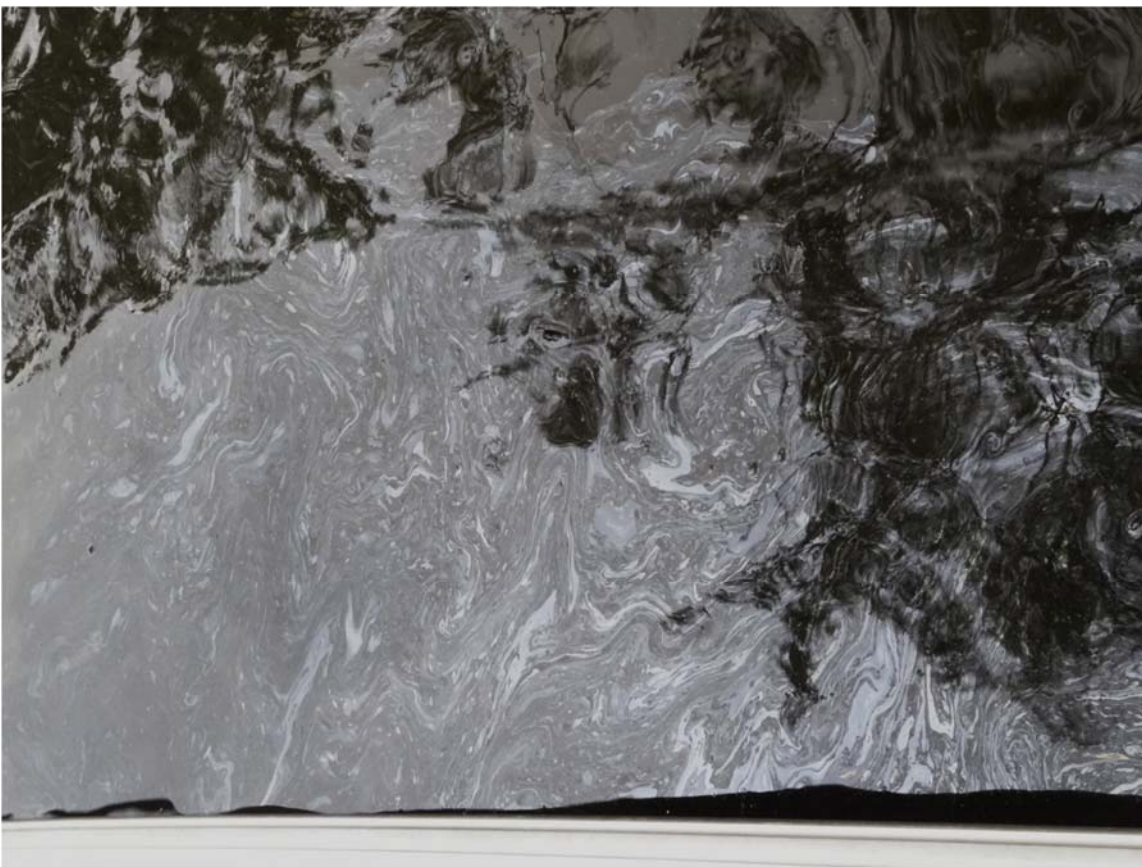
12. MP28.25 observed sheen when boat reversed away from the bank.

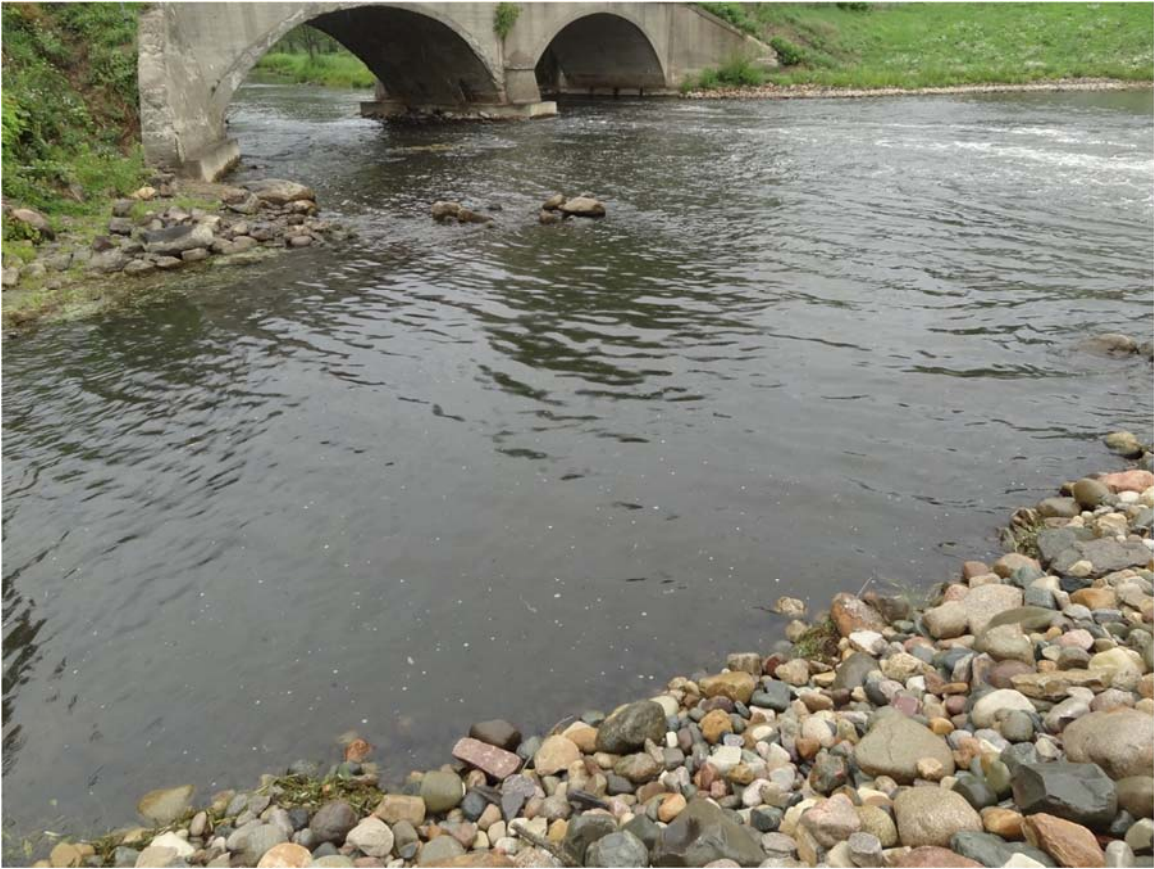
13. Ceresco Dam downstream portage, observed sheen.

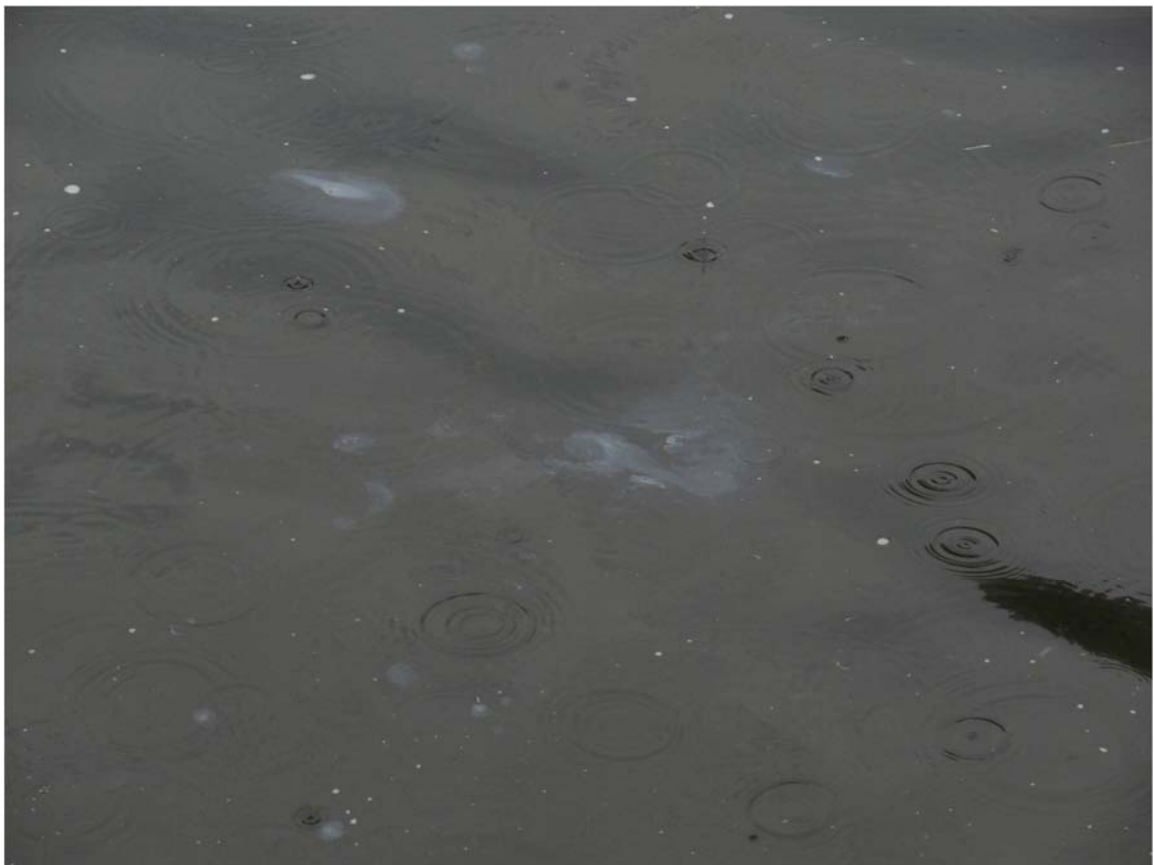
14. Ceresco Dam downstream portage, observed sheen.

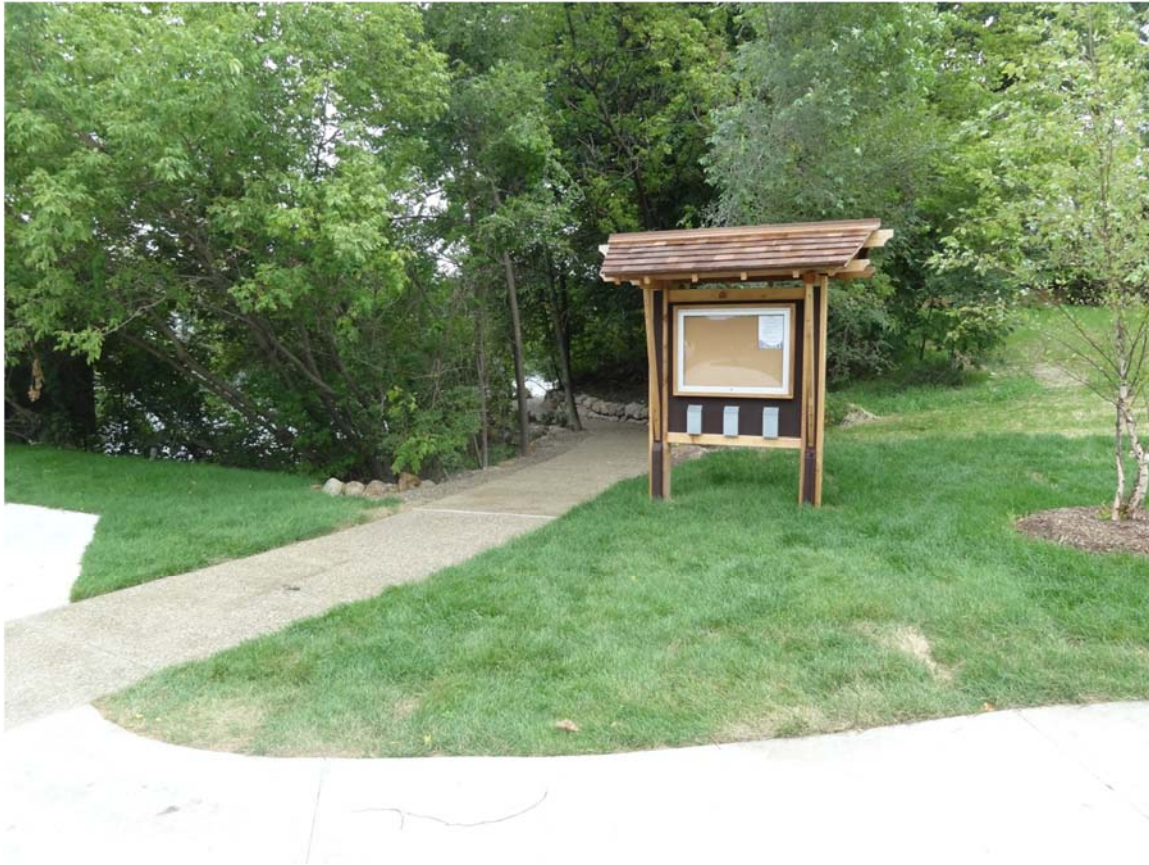
15. Ceresco Dam, no decontamination station observed.

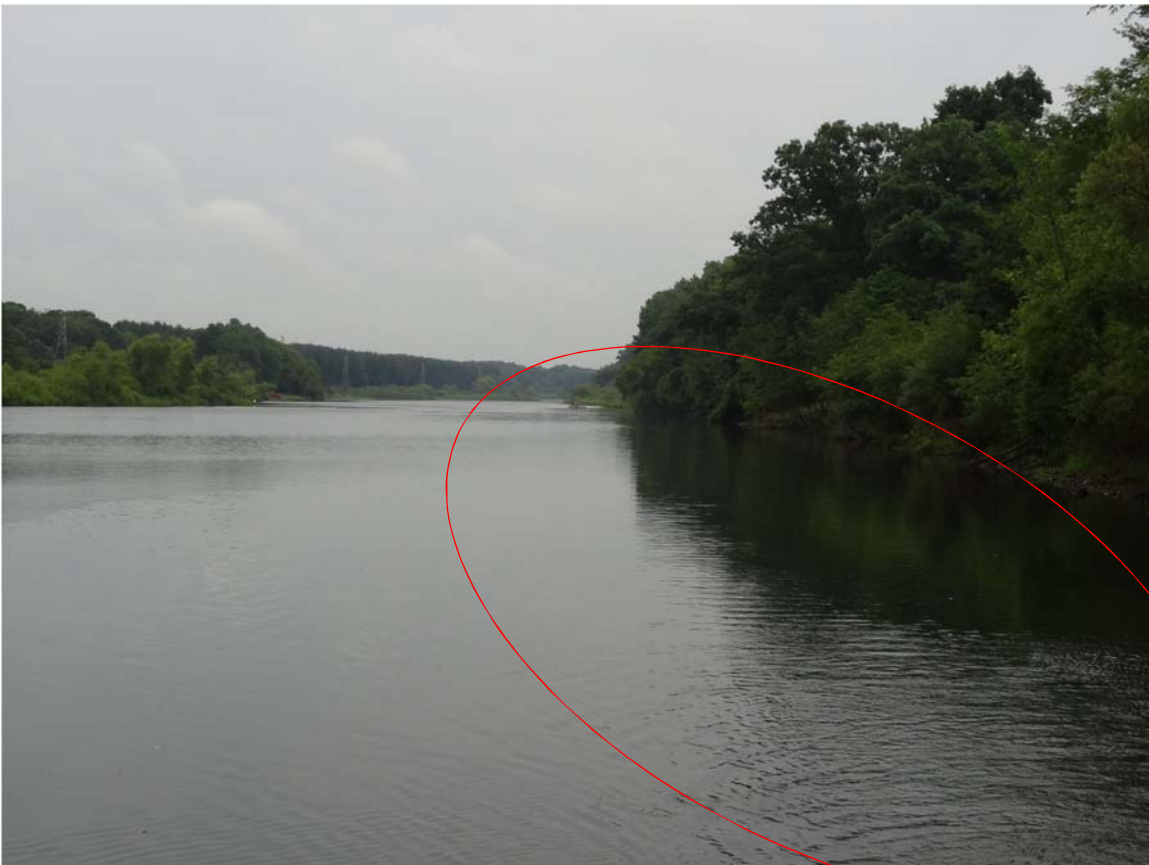
16. MP5.25 – MP5.5 LDB area where sheen was observed.

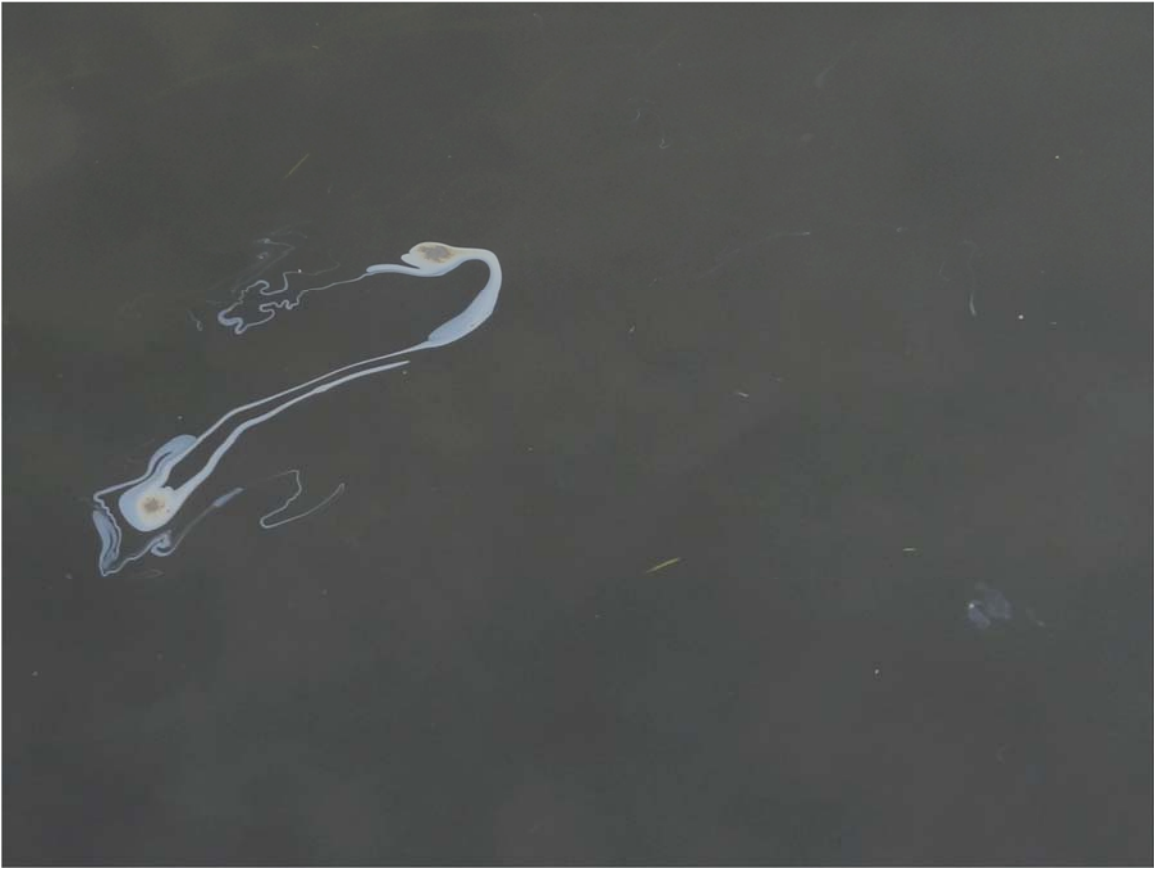
17. MP5.25 – MP5.5 LDB sheen was observed.

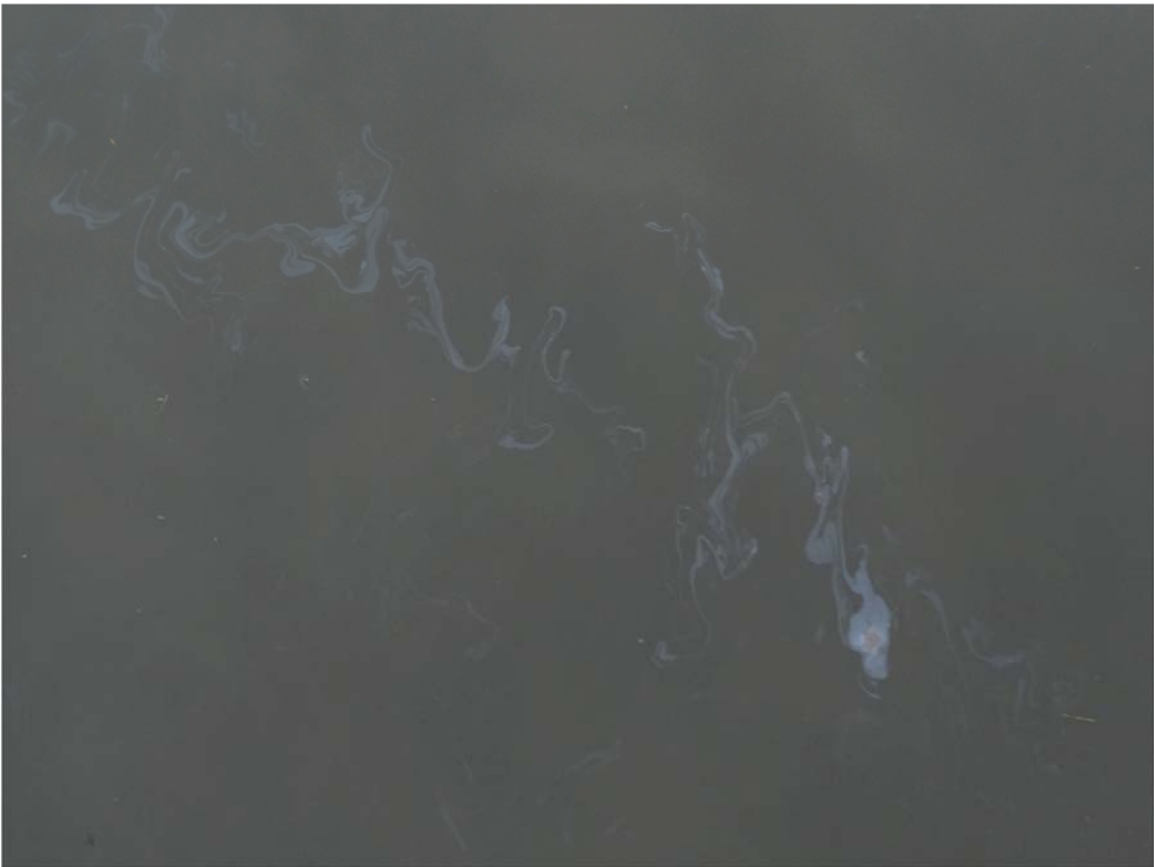
18. MP5.25 – MP5.5 LDB sheen was observed.

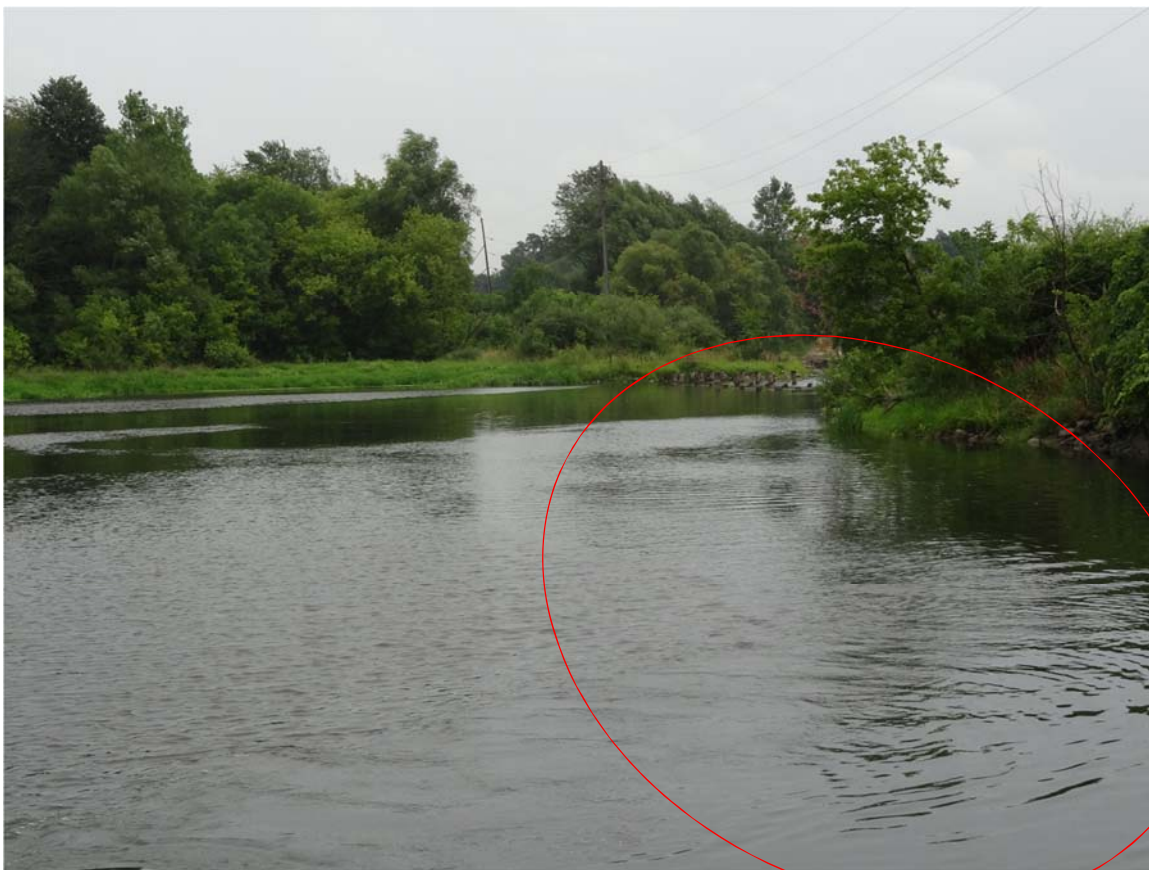
19. MP5.63 LDB area where sheen was observed.

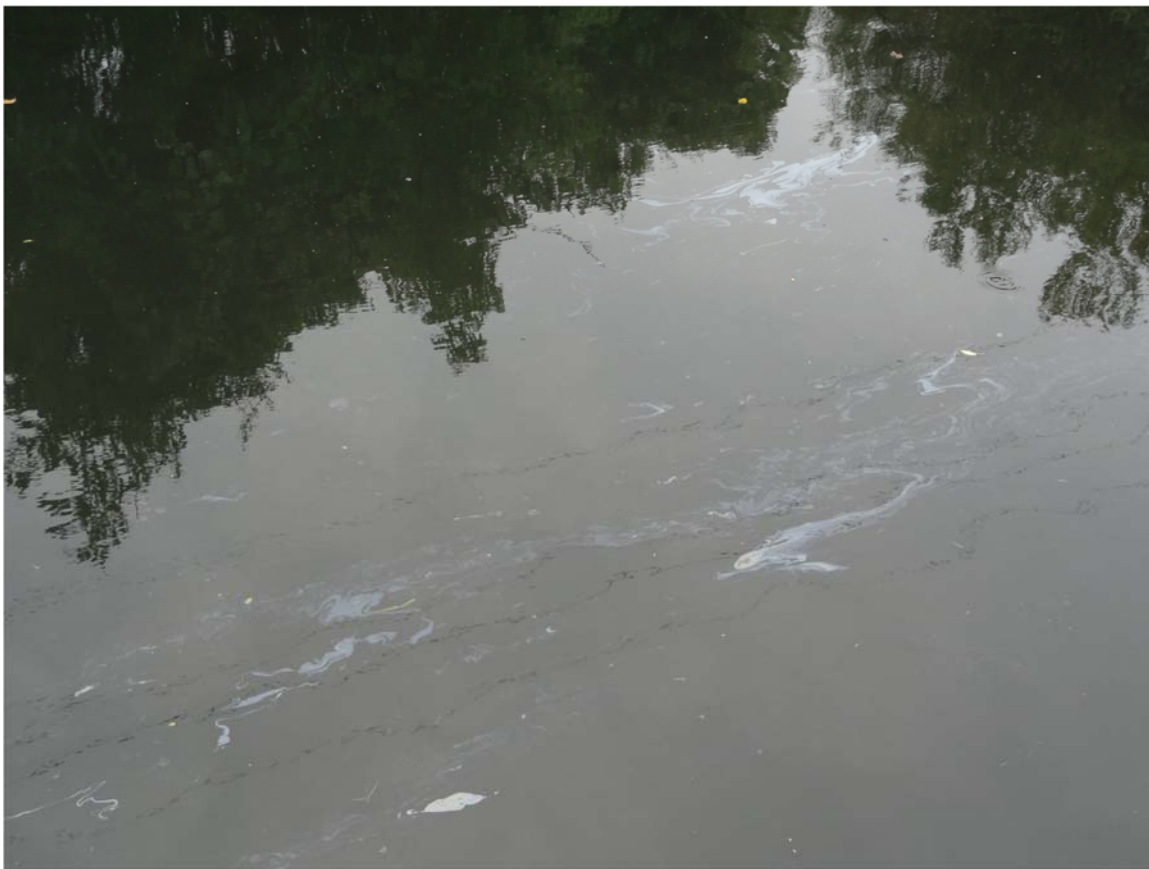
20. MP5.63 LDB sheen was observed.

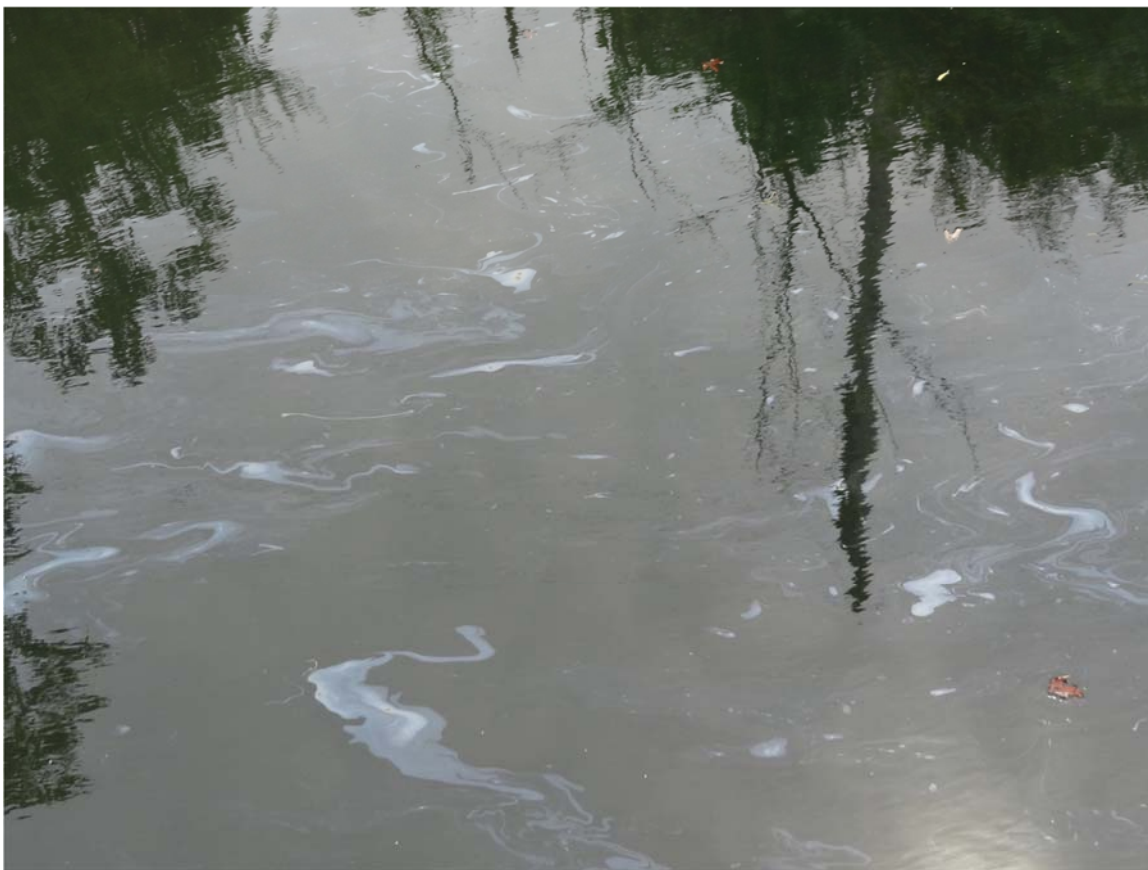
21. MP5.63 LDB area where sheen was observed.

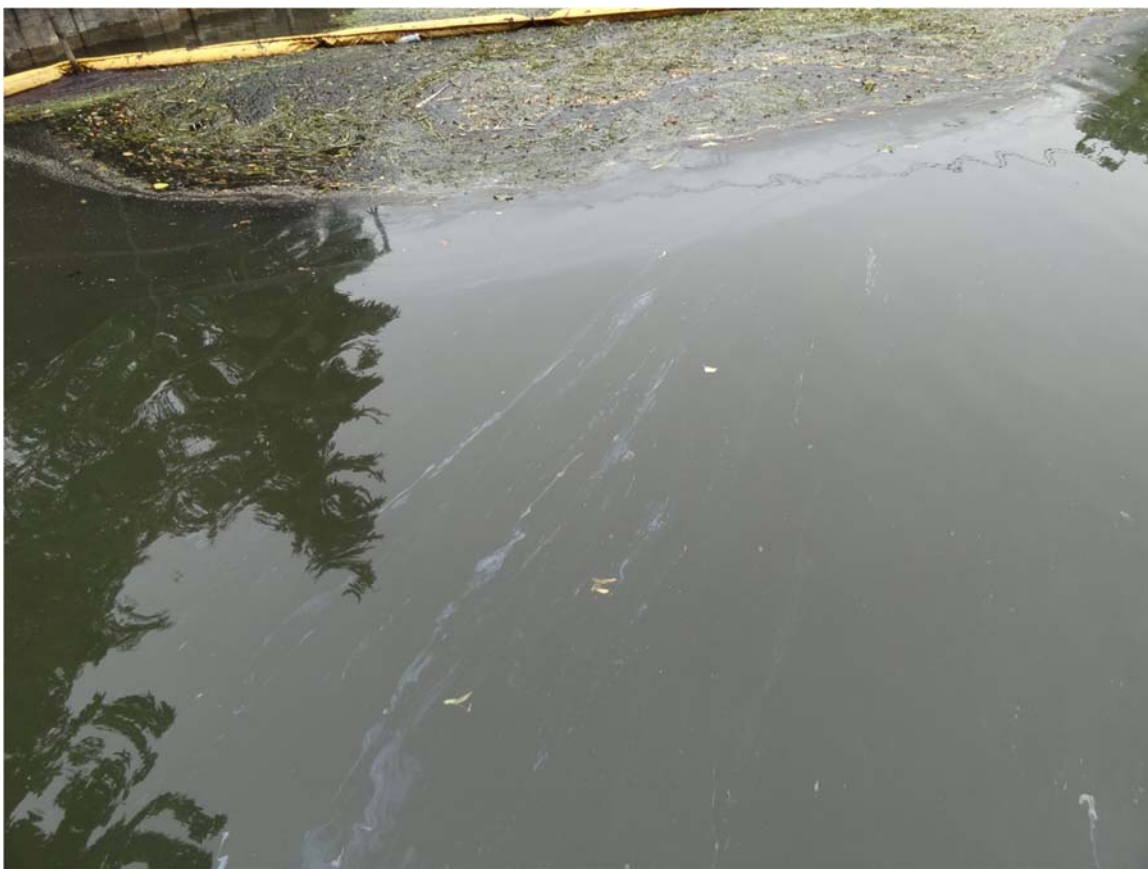
22. Ceresco Dam control point boom observed sheen and debris collecting along the boom.

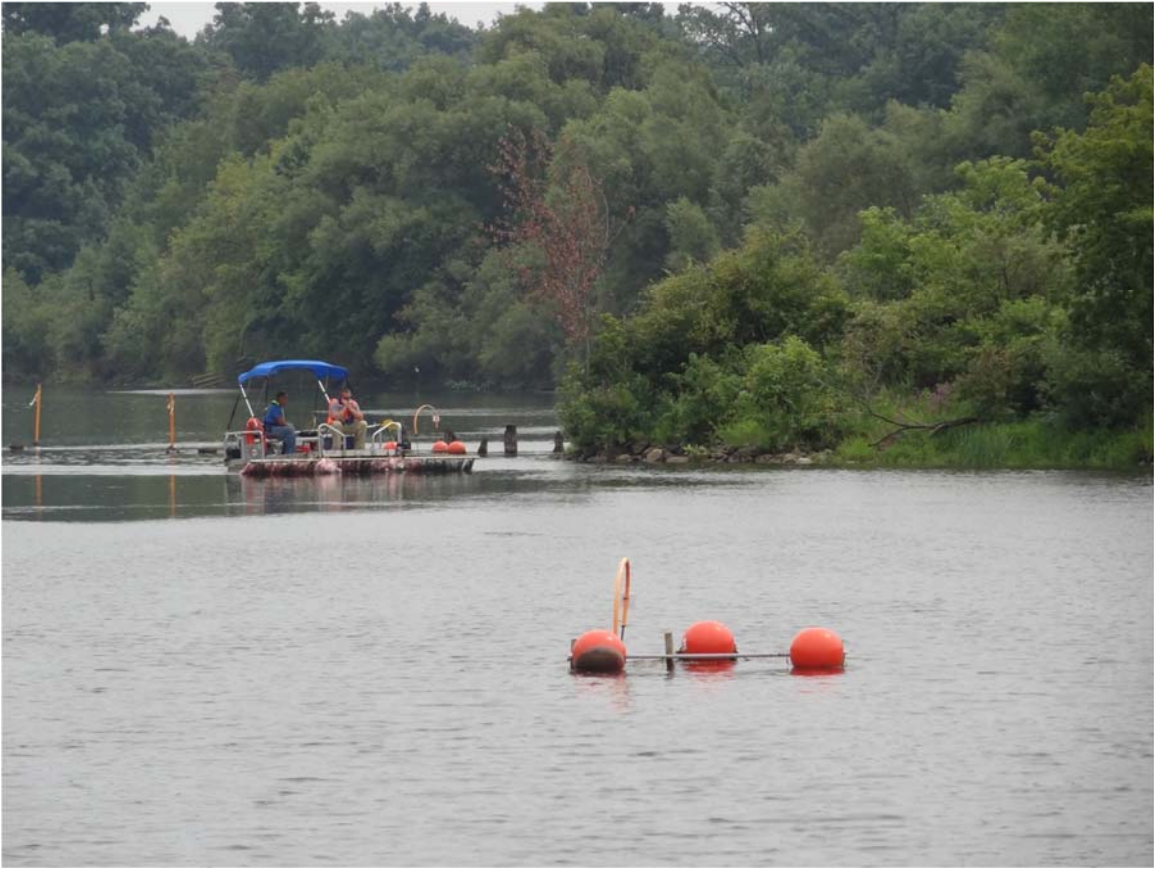
23. MP5.63 LDB observed the sweep boat operating.
